FIRMWARE UPDATING FOR THE JUMA TRX2 & PA100D

The Juma TRX2 transceiver and PA100D linear amplifier are designed in such a way as to permit easy updating of their firmware as modifications, enhancements, and bug fixes become available. This note described the procedures employed.

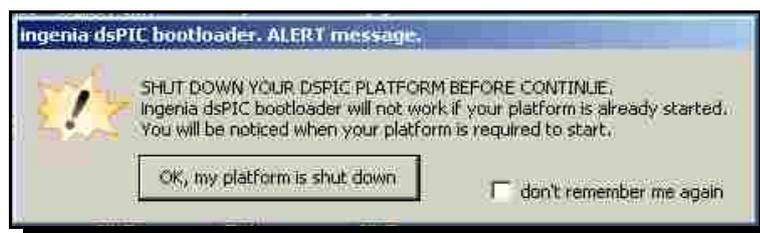
1. Connect the transceiver or amplifier to the PC serial port or USB-RS232 convertor using the appropriate serial cable.
2. Ensure the transceiver or amplifier is switched off.
3. Launch the Ingenia loader by clicking on its icon on the desktop. You should receive the following display:

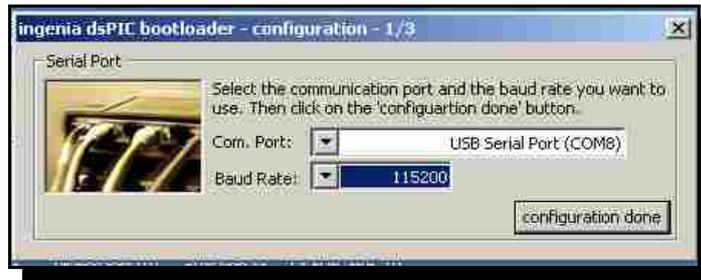
4. Click on the tab: 'OK my platform is shut down', and you should receive the following display:

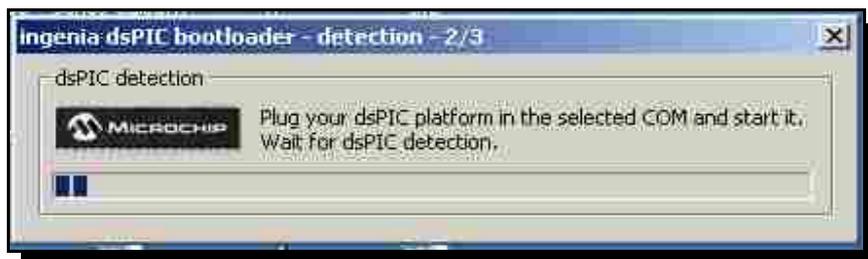
- Click on the Com Port tab and select the serial port you intend to use. Normally the program locates the correct port automatically. Then click on the Baud Rate tab and select the speed if you do not wish to use the default of 115,200 baud. Finally click on the 'configuration done' tab, whereupon you should see the following display:

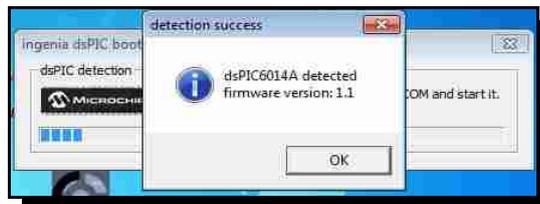
- Press and hold the VFO button on the transceiver, and then press the PWR button to turn it on. The transceiver will display a message that the flash writer has started. Wait until you receive the message that the Ingenia loader has recognised your platform. When it has been recognised, you will see the following display:

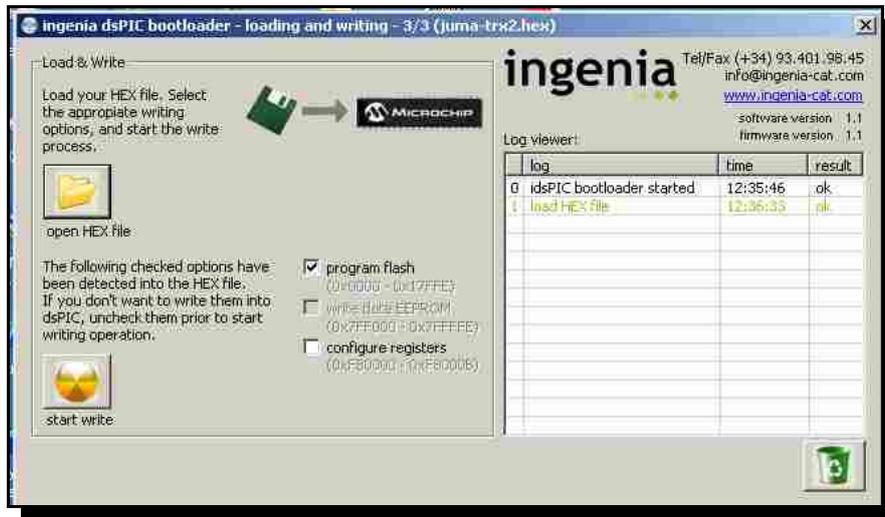
- Click on the 'open HEX file' tab, and navigate to the folder where your HEX load file is located, double click it to select and load it, and you should see the following display:

2. If an error message is provoked when opening the HEX file in step 7, this may indicate that either the HEX file has been corrupted, or that the installation of the Ingenia loader was incorrect. Download the HEX file again, and compare its 32-bit CRC with the original. Re-install the Ingenia loader and make sure that the configuration XML file is replaced.

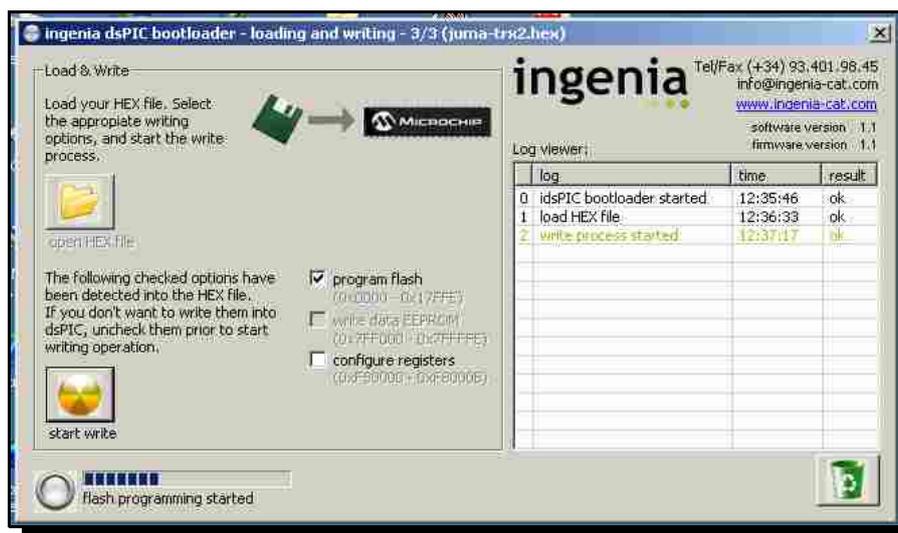
- Ensure that the 'program flash' box is checked, this should happen automatically as the HEX load file contains the necessary settings to do this. None of the other check boxes should be selected, nor should there be any error messages. Click on the 'start write' button, and you should see the following display:
